INDIAN FIELDS BRANCH, CUMBERLAND COUNTY

# EAST LAKE DAM

## PHASE I INSPECTION REPORT NATIONAL DAM SAFETY PROGRAM

MARCH 1978

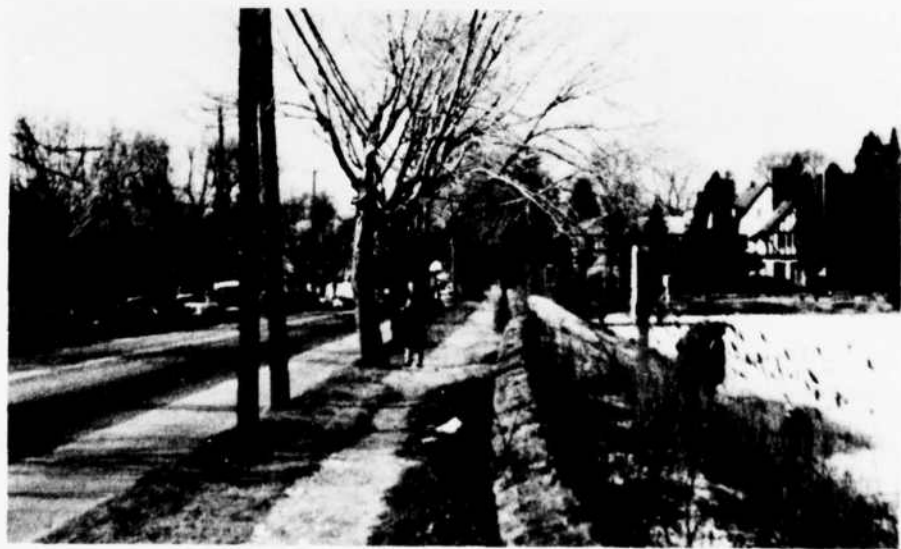
TOP OF DAM LOOKING WEST—UPSTREAM SIDE

a. Dam. The dam is an earth embankment with a stone wall on the upstream side of the crest. The stone wall is noticeably settled and tilted. The upstream slope consists of a loose sand fill which shows evidence of erosion and settlement. Vertical depressions of 2 to 3 feet are evident near the water surface. There are no training walls at the outlet structure to protect against the effects of erosion in this area. Erosion to depths of 3 to 4 feet is apparent for a length of 30 feet west and 50 feet east of the outlet structure. Sand has been placed in these areas to protect the embankment.

d. Repair of wall on the upstream side of the roadway.

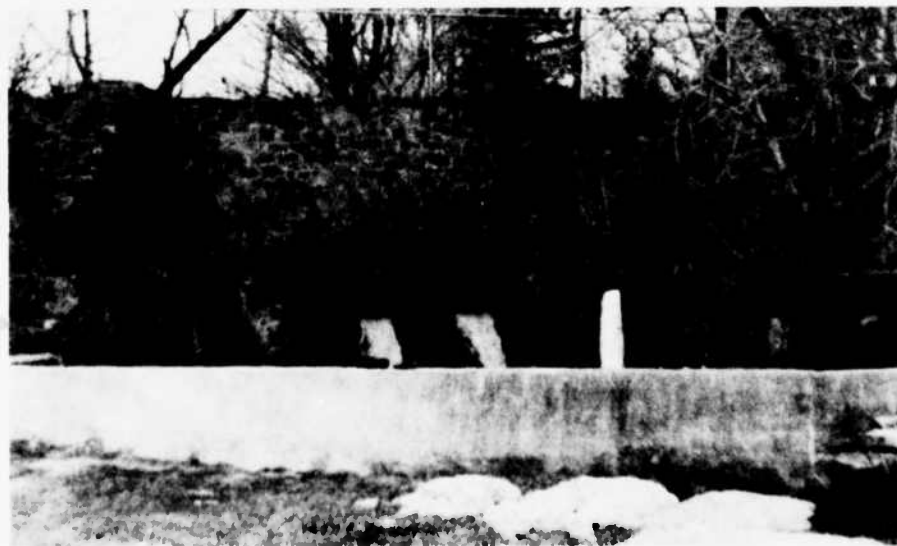
OUTFALL FROM RESERVOIR OUTLET STRUCTURE
